The Measuring Gauge:

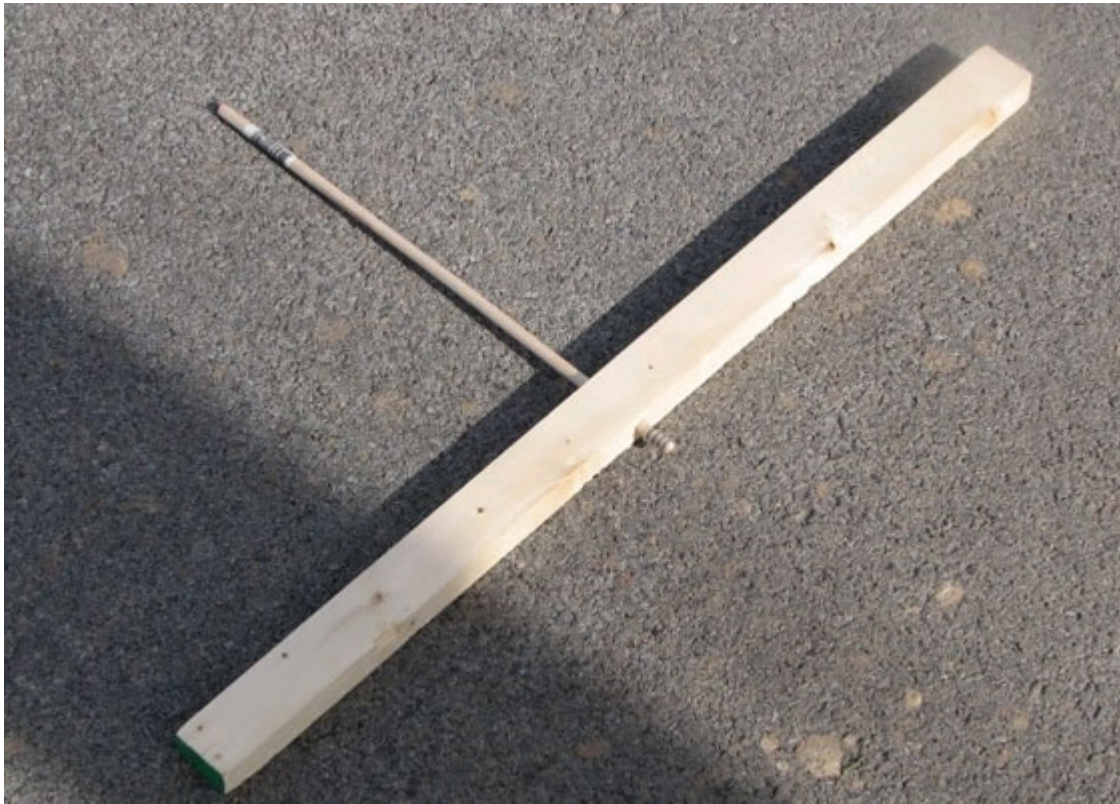
The piece of 1x2 was jointed to make sure it was flat and a 1/4" hole drilled in it to accommodate a piece of dowel, which was carefully marked with 1/8" increments while it was turning on a wood lathe. Each picture attached has the measuring gauge and an identifying number from the map in it.

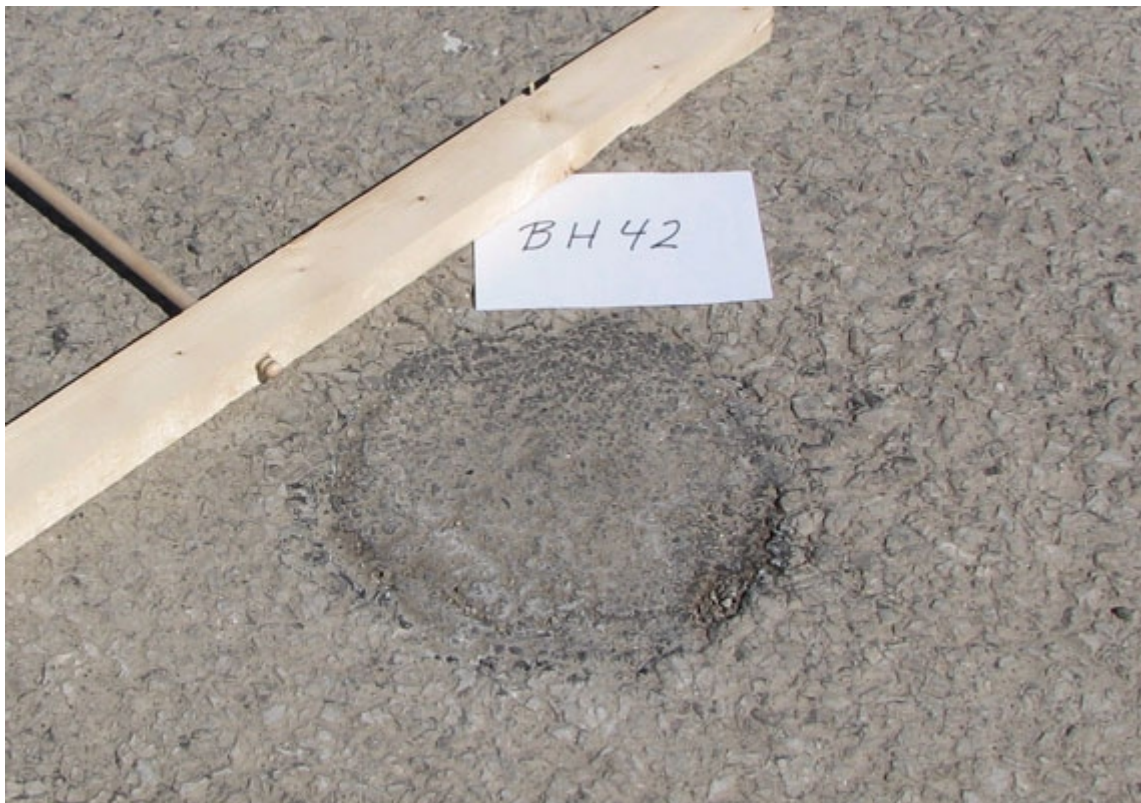
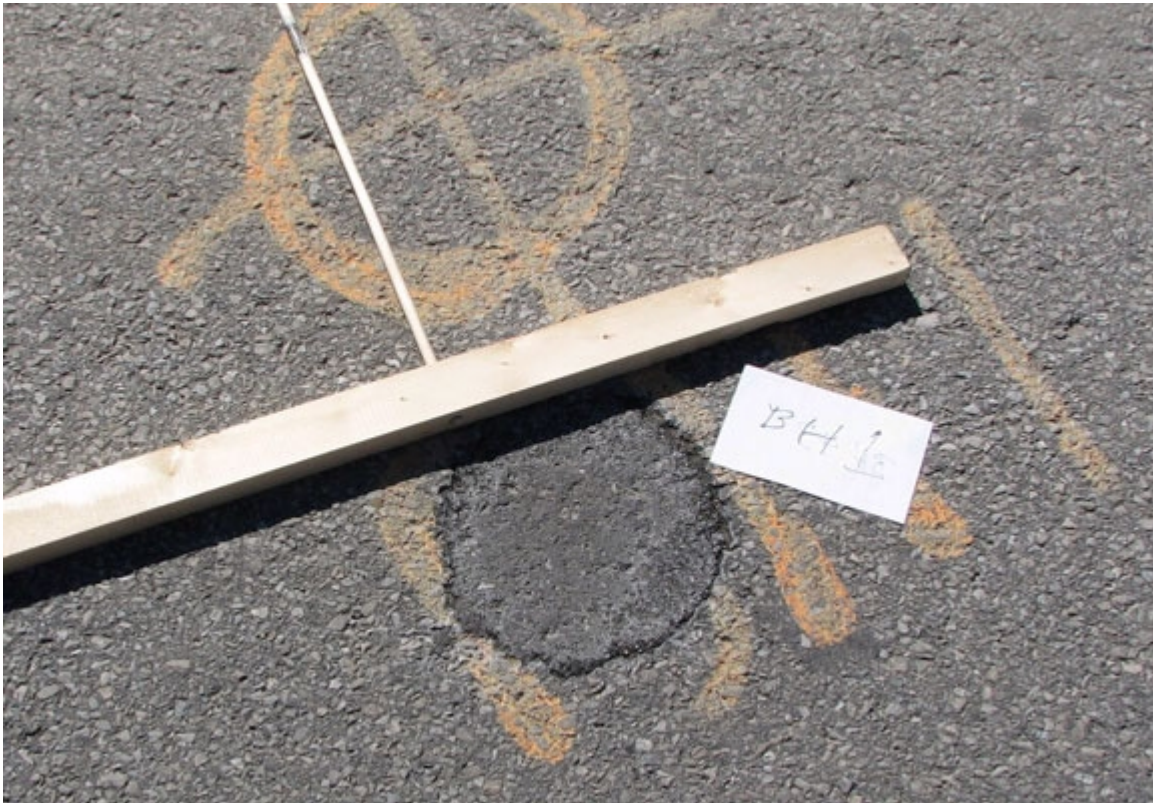
On Centre Road north of the bend above the 11th, on the East side there are two bore holes adjacent to each other. Bore hole 1 is marked with orange paint and a stake and the other (BH42) is just a few feet south of B1. BH 1 has a depression depth of 1/8" and BH 42 is a bit over 1/4" at the deepest part.

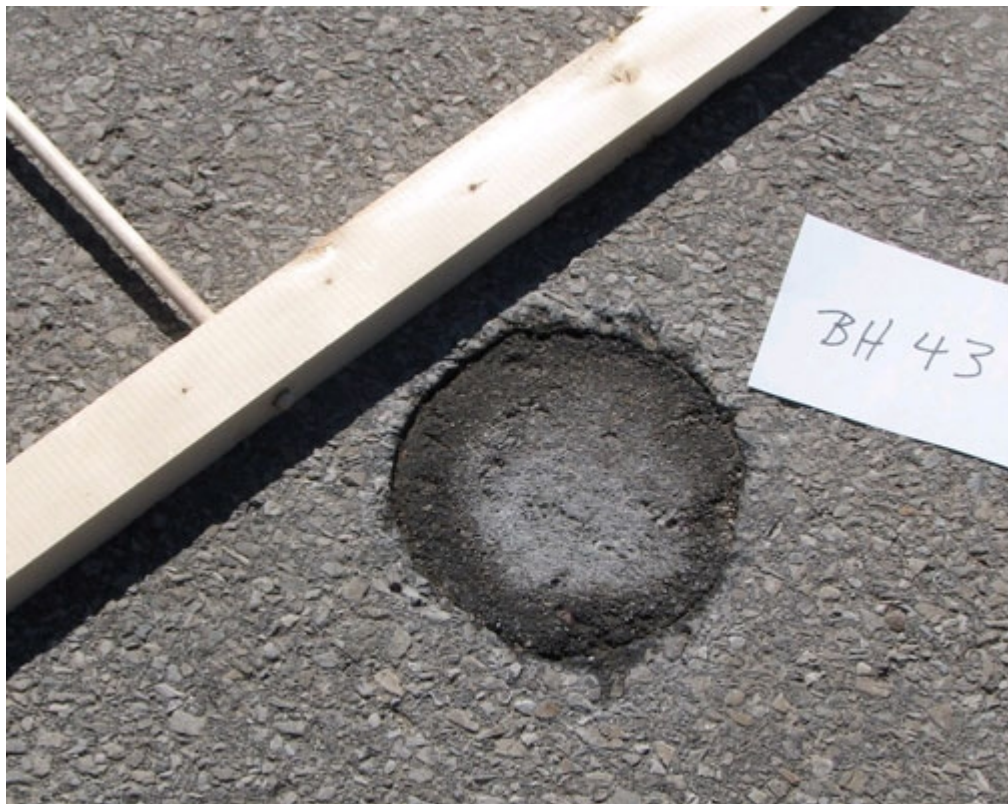
BH 43 is on the west side of Centre Road just at the bend north of the 11th. The depth is about 1/8"

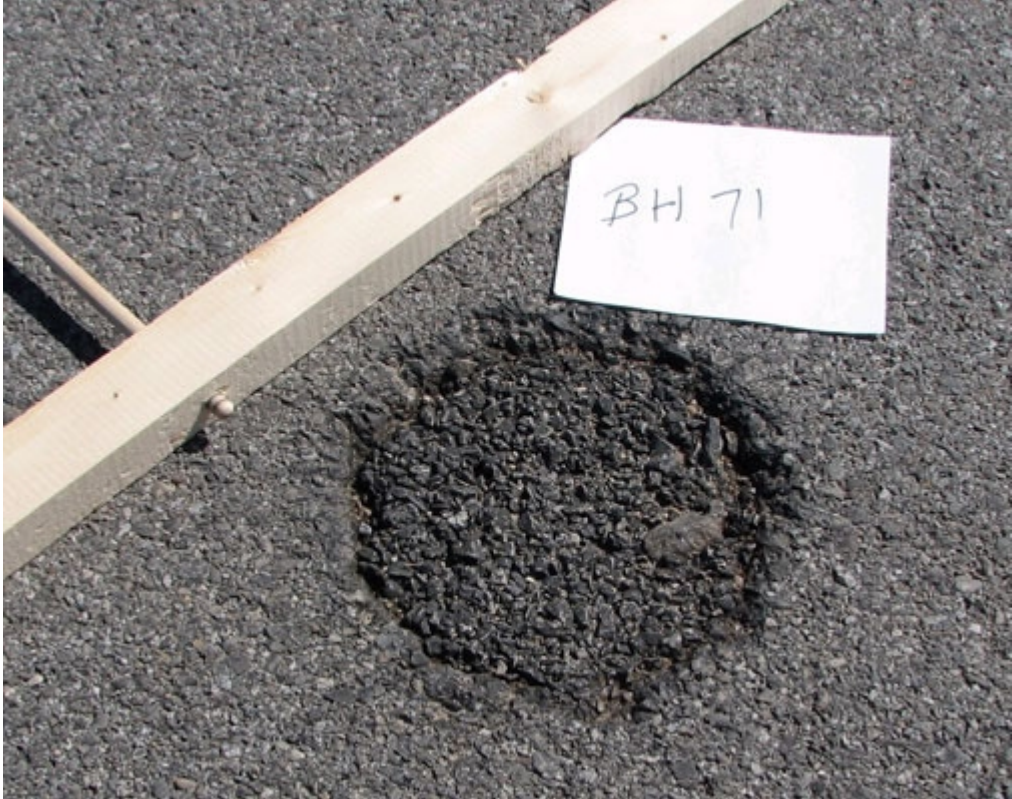
BH 71 is on the north side of the 11th between Stonebury and Centre Road. This was originally found full of water when the road was damp. The patch for it is extremely coarse and the depth over 1/4" at the shallowest point. The edge has lots of places to hold moisture for winter freeze/thaw action.

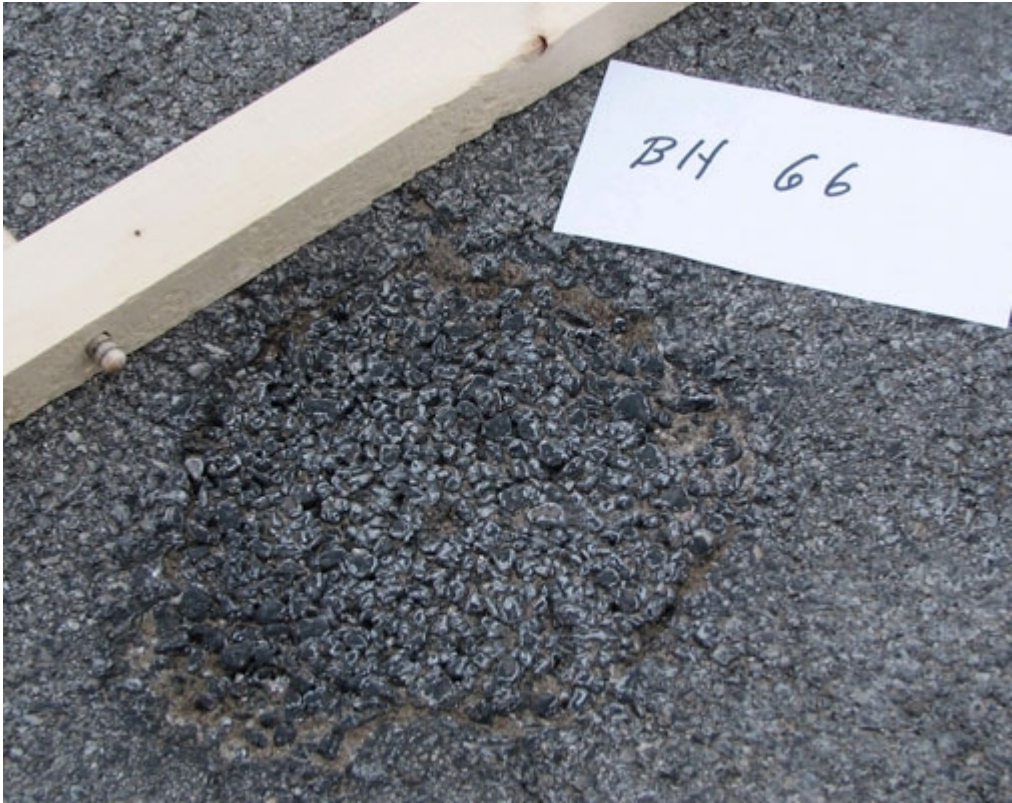
BH 66 is on the south side of the 11th west of Milborough Line with a depression greater than 1/4" and lots of water catching voids on the perimeter.

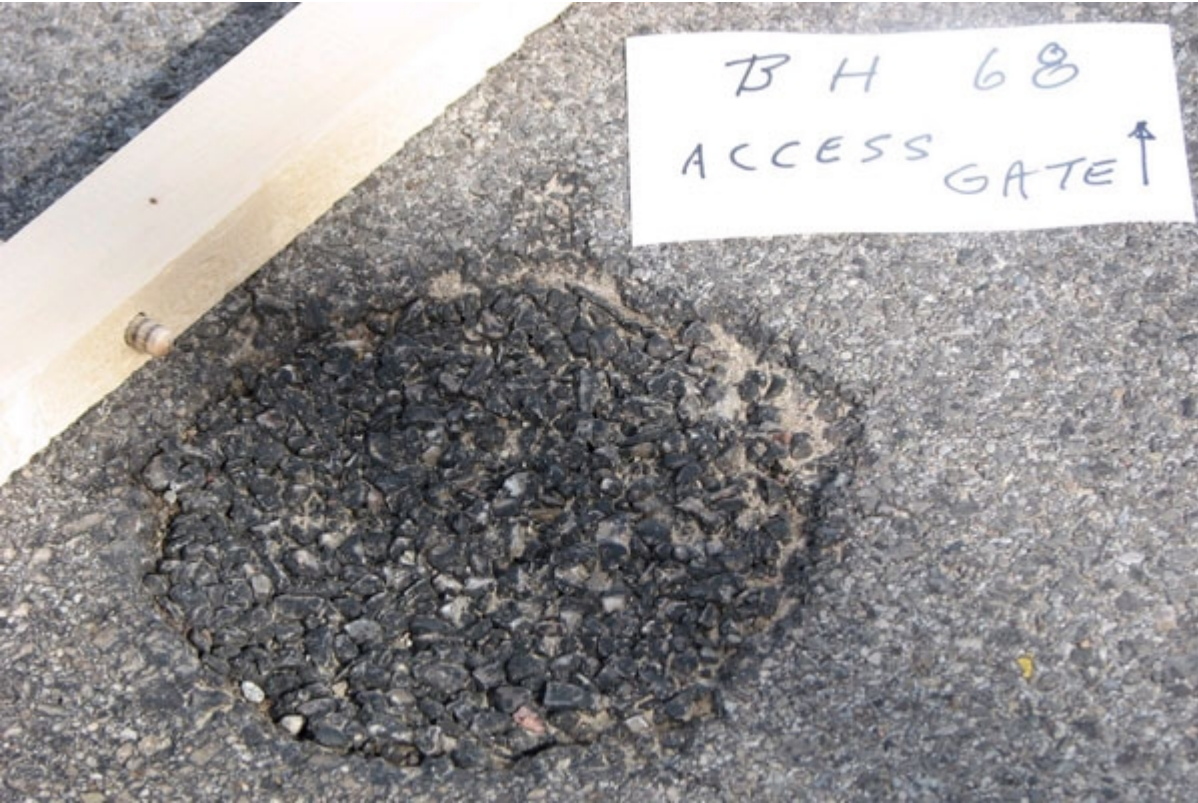
BH 68 is on the south side of the 11th, almost directly across from the property gates. The depression is in excess of 1/4".

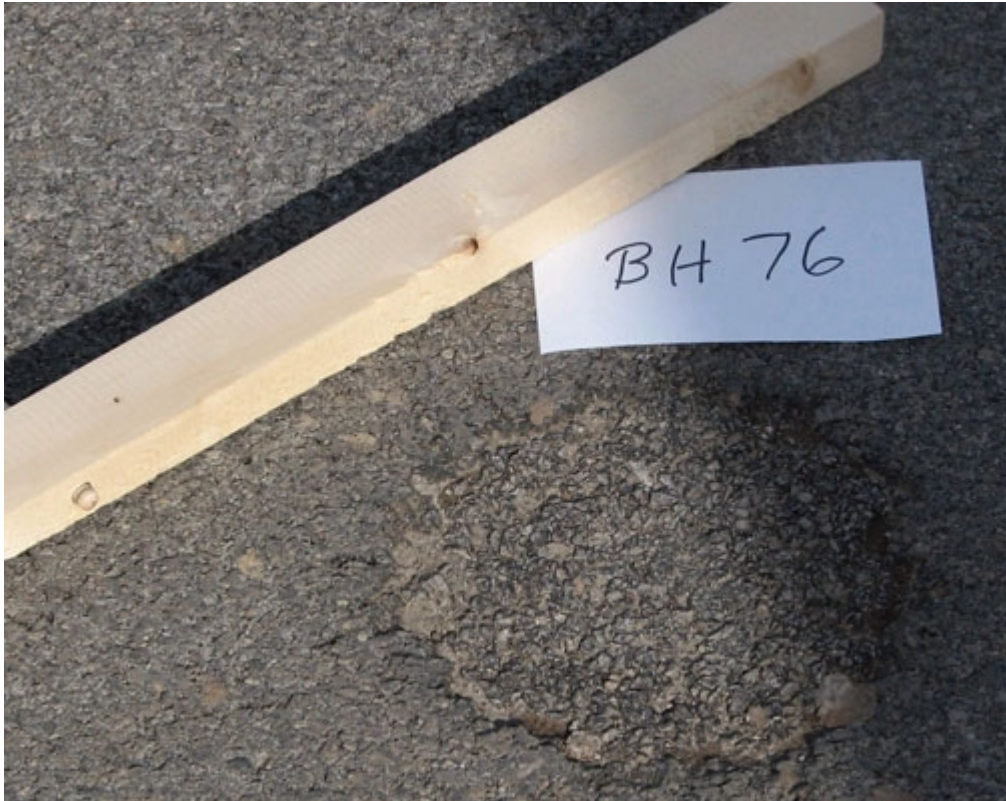
Lastly is BH 76 on the south side of the 11th just east of Highway 6. It has ragged edges and a depression of about 3/16"
